Manhole Inspection Summary

Manhole # S25EE_016MH

Insp Date: **7/20/07 8:22 AM**

Location Address: **1201 WINCHESTER ST**

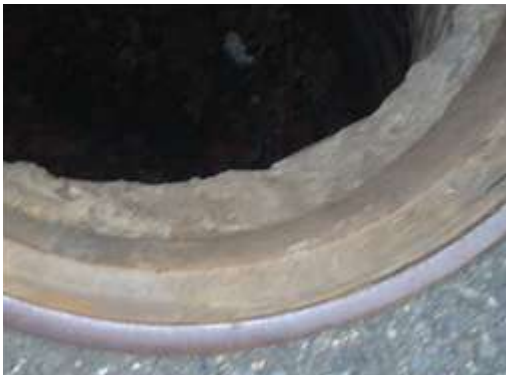
Defect 1

Offset: **2** (in.)

FRAME OFFSET

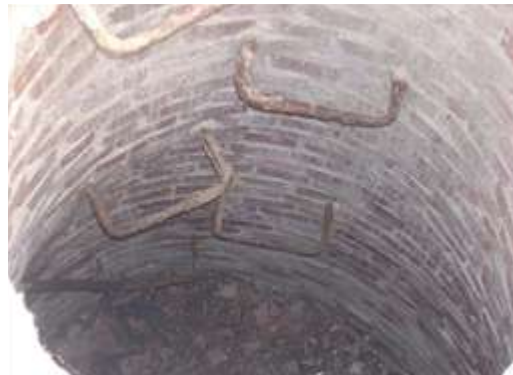
Defect 2

Count: **5** Missing: **0** ☒ **Corroded**

CORRODED STEPS

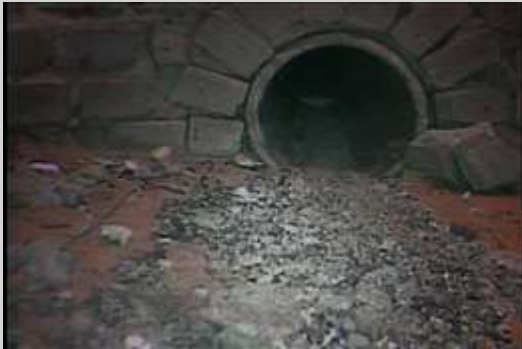
12 O'Clock Outflow

CHANNEL DEBRIS

Pipe Height: **8.4** (in.) Rod and Bar (Angled)
Pipe Material: **Clay** ☐ Pipe Lined
Invert Depth: **8.74** (ft.) Flow Characteristics: **None**
Deposits: ☐ None ☐ Mud ☐ Sludge ☒ **Debris** ☐ Grease
Silt Depth: **1** (in.) Deposits Extent: **Light**
Infiltration: **None** Pipe Seal Cond: **Sound**

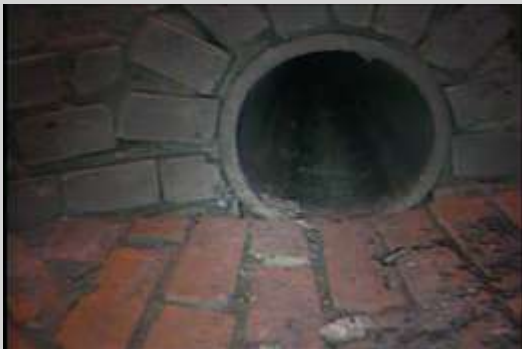
3 O'Clock Outflow

Pipe Height: **8.4** (in.) Rod and Bar (Angled)
Pipe Material: **Clay** ☐ Pipe Lined
Invert Depth: **8.38** (ft.) Flow Characteristics: **None**
Deposits: ☒ **None** ☐ Mud ☐ Sludge ☐ Debris ☐ Grease
Silt Depth: (in.) Deposits Extent:
Infiltration: **None** Pipe Seal Cond: **Sound**
